Navajo Abandoned Uranium Mine

Site Screen Report

**Mine Name: Mail Box Claim
Mine ID: 853**

April 2012

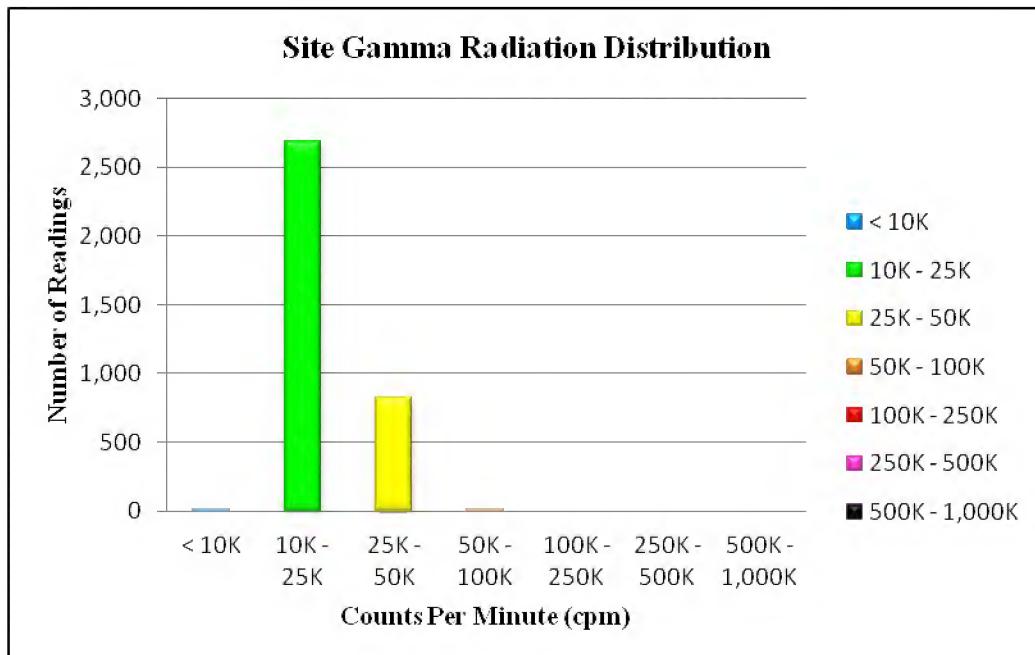
Distribution Chart and Statistics:

A total of 3,527 gamma radiation measurements were collected from the mine site, ranging from 9,101 cpm to 56,433 cpm. The measurements are represented in Figures 1 and 2.

Site Gamma Radiation Statistics	
Number of Readings	3,527
Minimum (cpm)	9,101
Maximum (cpm)	56,433
Mean (cpm)	21,649
Median (cpm)	19,116
Standard Deviation	7,248

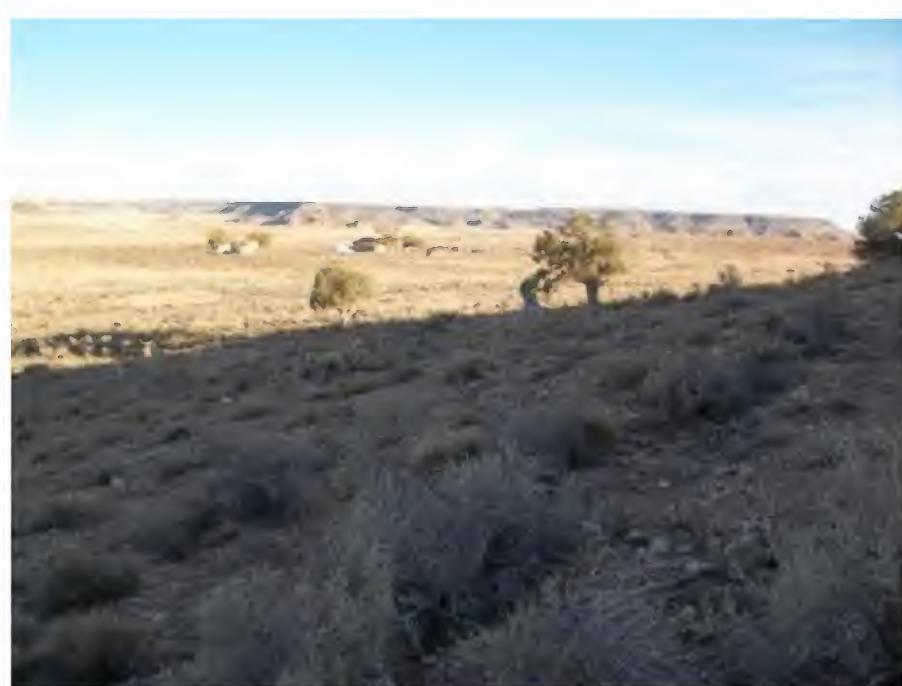
Photo 1

Mine Site #853

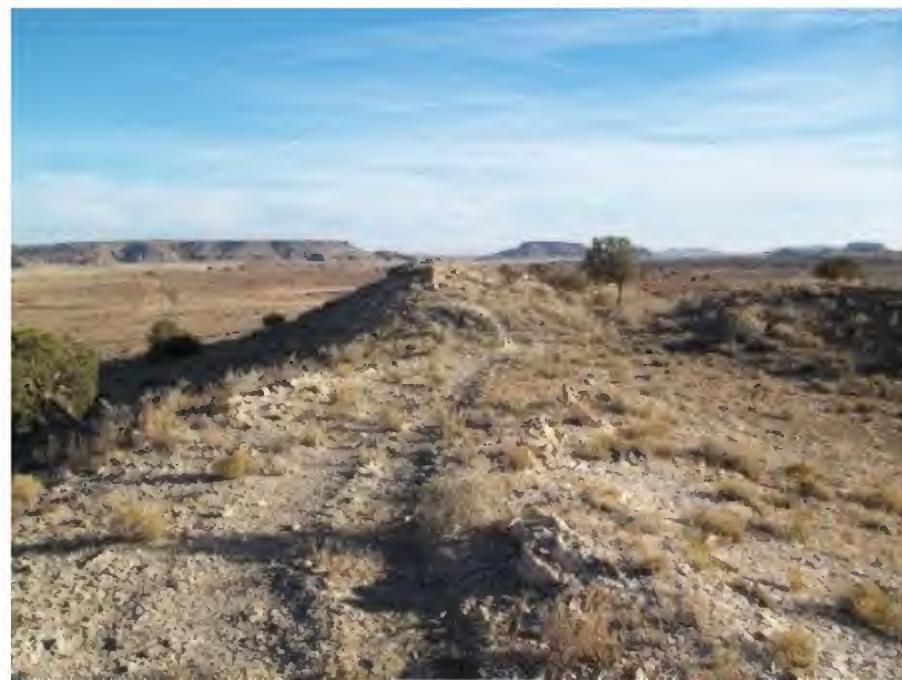
Photo 2

Mine Site #853

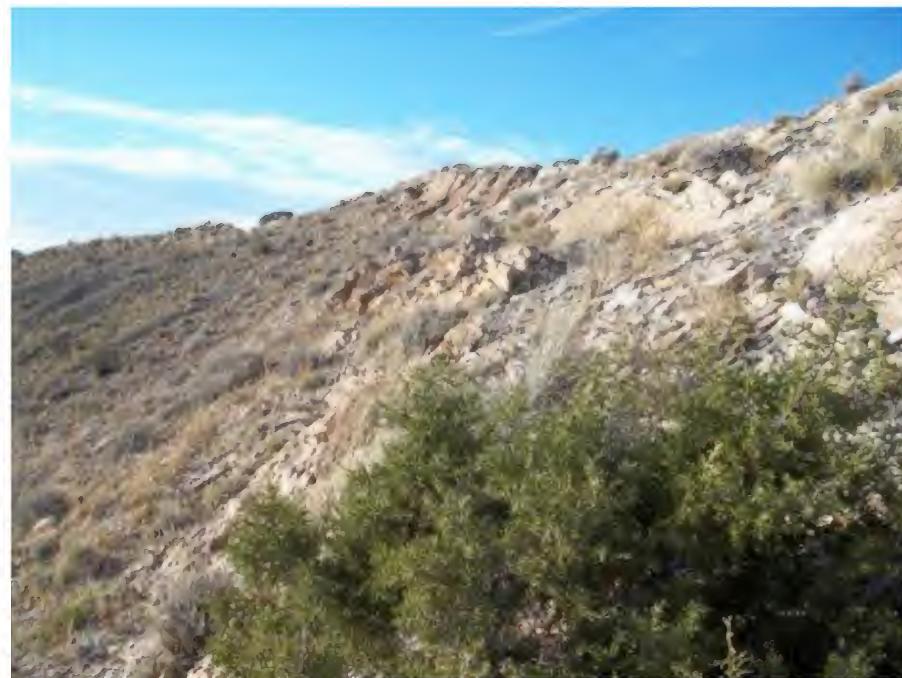
Photo 3

Mine Site #853

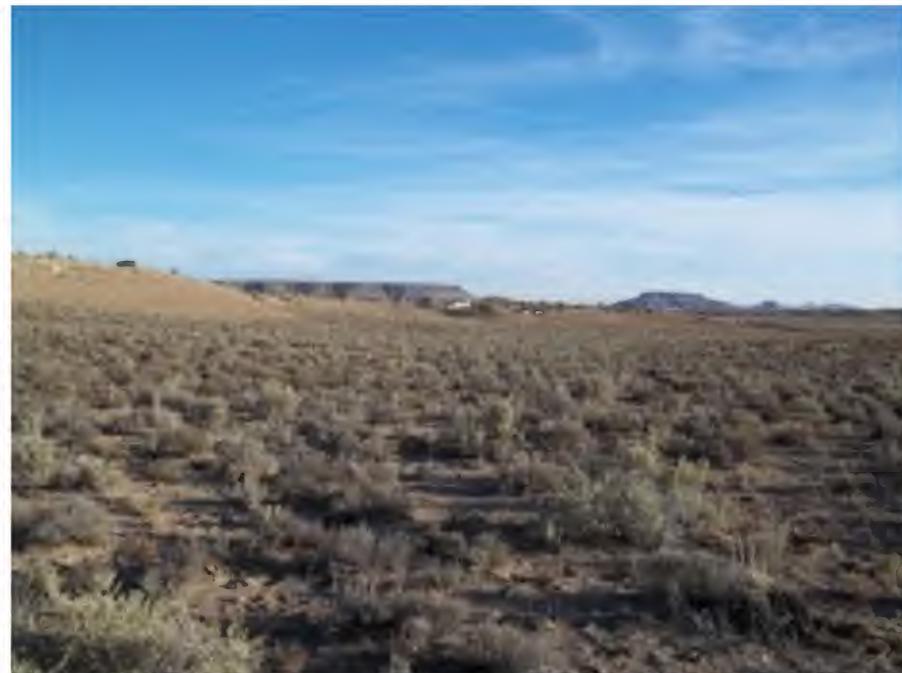
Photo 4

Mine Site #853

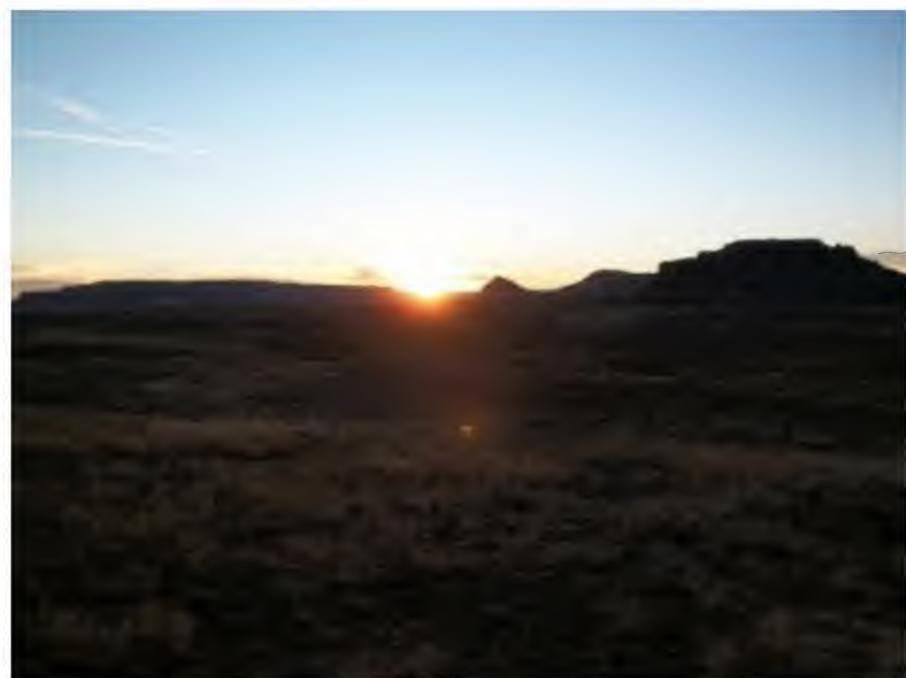
Photo 5

Mine Site #853

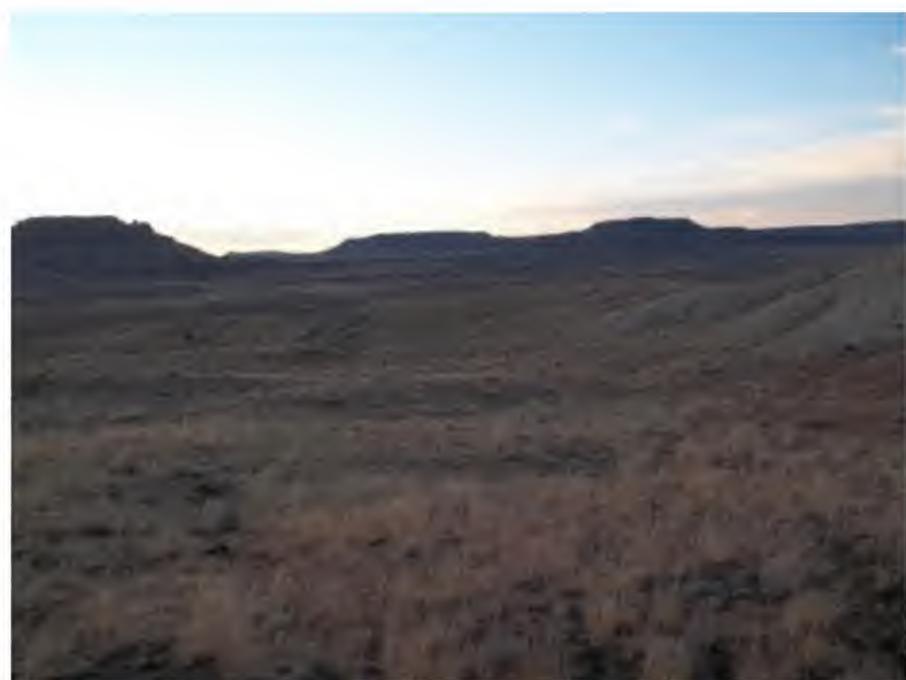
Photo 6

Mine Site #853
